## Trench 1 Sector C

### Sector C: The Contexts

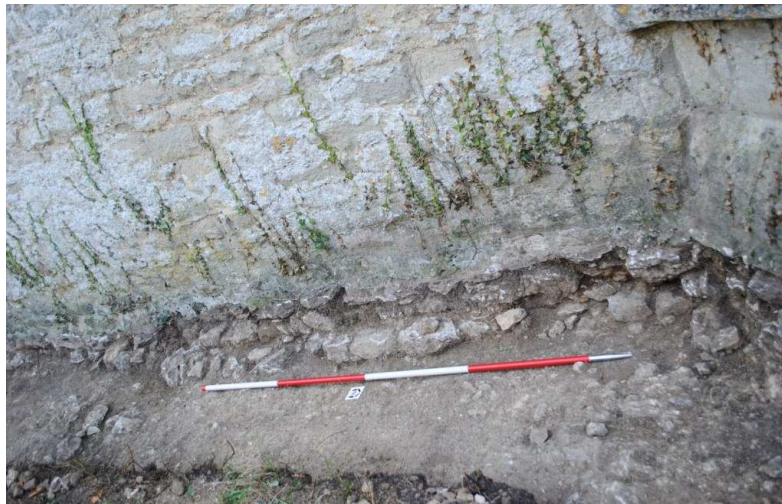
*Figure 38 Upper layers of Sector C: looking WSW*

In the southern part of the sector (areas E to J), topsoil removal was taken to a depth of up to approximately 0.30m. Here a rubbly area was revealed in the centre of the sector (areas H and G), with a mortar floor to the north and an exterior area to the south which remained largely unexcavated. Area F had the feel of more loosely deposited material. Area G was darker and so was Area H III. The darker soil, the contamination, and the presence of a fragment of human skull, and other pieces of bone, were suggestive of burial(s).

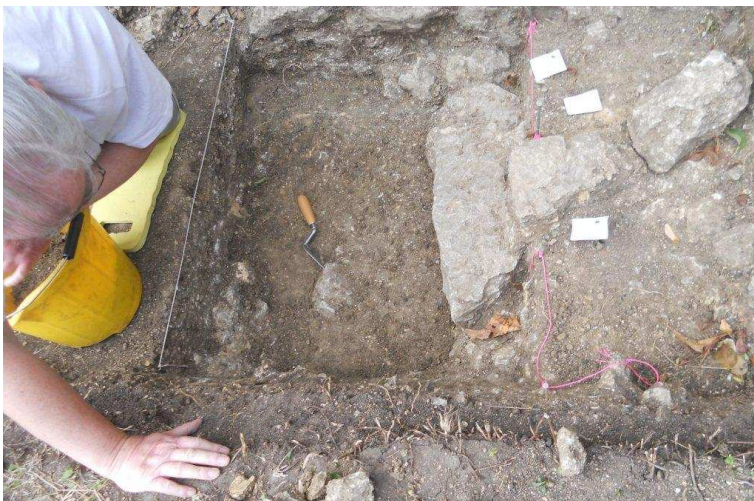
*Figure 39 Excavation of slot underway: looking west*

A slot was opened in (1001) immediately south of the mortar floor, which revealed a very disturbed layer of brownish grey material (**1010**), 60% silt plus coarse sand and clay and sand lenses (Plan 1.12). Within this layer were a number of other smaller limestone fragments, a little floor-tile, some pieces of gryphea, and human bone fragments amounting to about 3% of the whole.

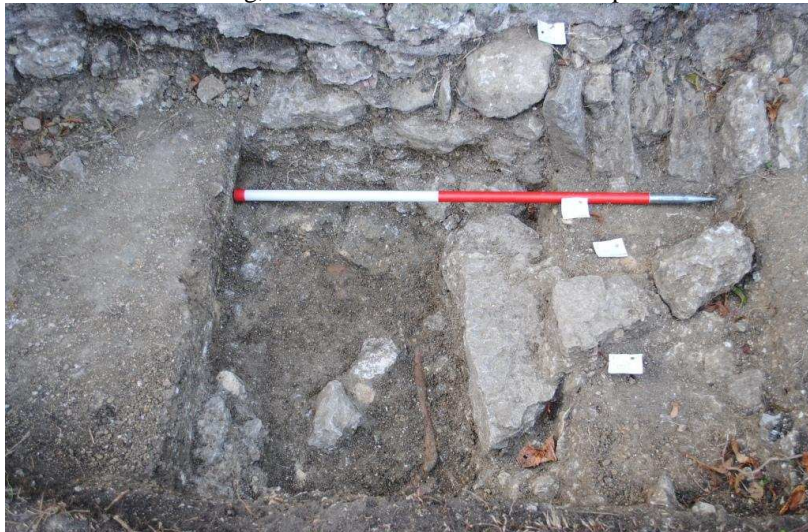
*Figure 40 Skeleton 1 emerging: looking west*

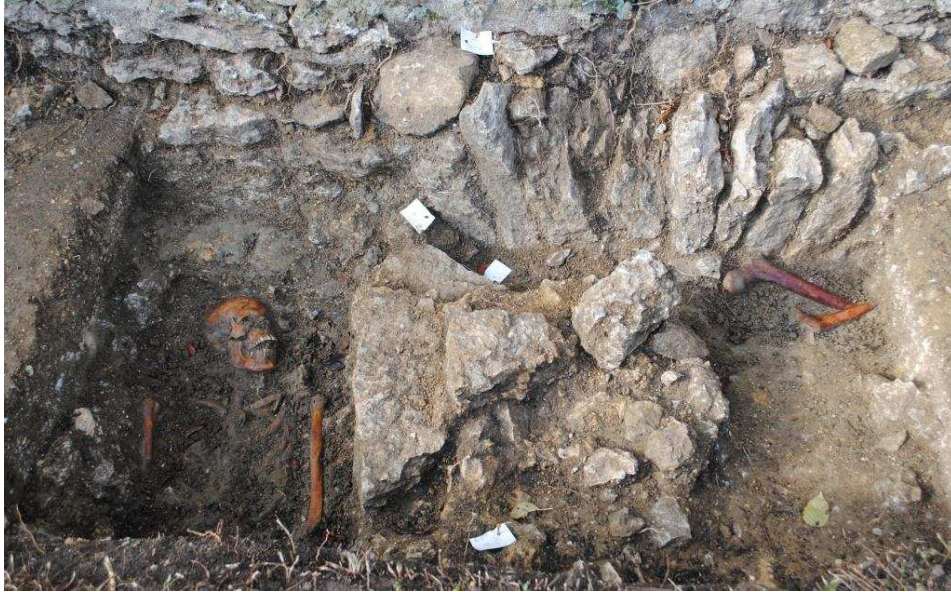
*Figure 41 Skeleton 1: looking west*

Revealed during the removal of layer (**1010**), and found to be cutting into it, was the cut for the grave of a young male, Skeleton <1> [**1017**] (Sections 110, 111; Plans 1.4, 1.12, 1.14, 1.16) – which also cut into the clay of the foundation trench of the chapel wall (1018) (see below). The cut for the burial was rectangular with a rounded head on the west. There was evidence of stone lining on the south and the north of the grave was bounded by mortared limestone courses associated with an earlier structure. The grave fill (**1016**) was characterised by silty clay with pebbles and mortar/plaster fragments. The lower half of the grave, including the lower arm bones and the pelvis, was excavated in Stage 2. Here the remainder of the grave fill (**1049**), including the lower arm bones but not those of the hands and fingers, and only the upper leg bones, cut into by the evident fill of a further, superimposed grave for Skeleton <12> whose assumed recut [**1052**] was not seen but appeared to have caused the destruction of much of the eastern end of the structured sides of the grave of Skeleton <1>. Skeleton <12> was represented by its skull and some other bone fragments.

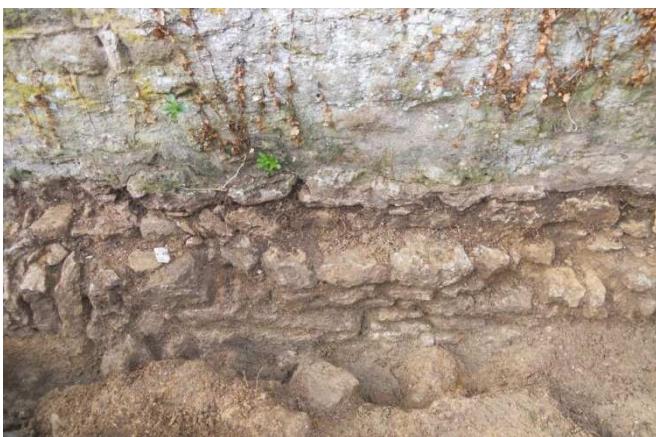
*Figure 42 East wall of the Chapel with phases of rebuild: looking west*

On a line roughly parallel to, and ~0.15m east of the east wall of the chapel, (1038) below, this gritty layer (1041) was truncated by a cut [1040] which may be taken as further evidence of the probable foundation trench for the fourteenth-century chapel represented by (1018) (see below). The dark brownish green to dark brown fill (1034) of slightly gritty or clayey silt (with the silt representing 80%) included large structural stones as well as the matrix for an assemblage of human limb bones deposited north-south against the lowest courses of the structure immediately under the east wall of the existing chapel.

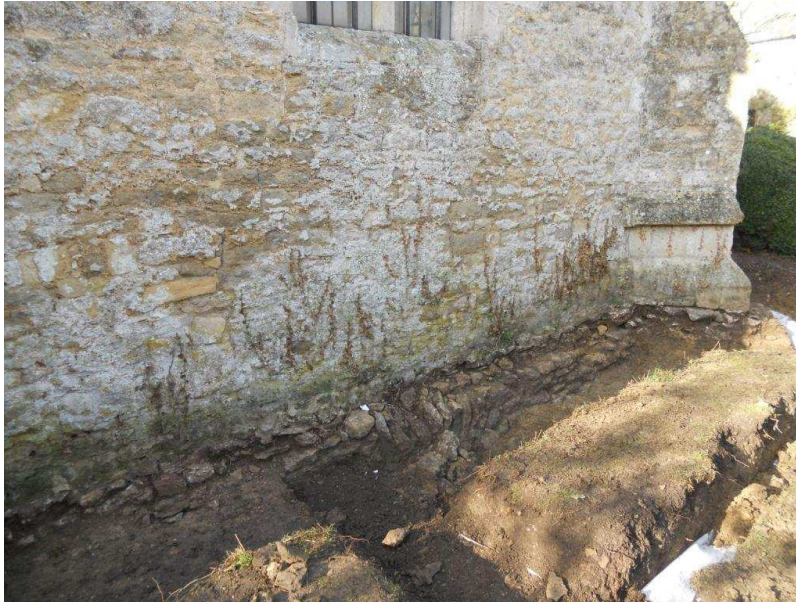
*Figure 43 East wall of the Chapel: looking NW*

The existing east wall of the chapel (1038) (Elevation 120; Plan 1.12) is of mostly roughly-mortared limestone and rubble, with one or two blocks of darker stone (one possibly of sandstone and another apparently igneous). The stones are of varying size, up to ~0.30m. The bonding is generally in poor conditions, intermixed with soil, grit, and small stones and pebbles.

Possibly up to four phases or elements of construction appear to be visible. The observation begins with a line of moulding around the north-east buttress which continues south for a few centimetres from the buttress's south-west angle before ending in a break. This suggests that the buttress and its underpinning belong to an earlier structure than the existing east wall of the chapel. This seems more likely than relocation from another site, followed by reconstruction and incorporation into the existing structure of the chapel.

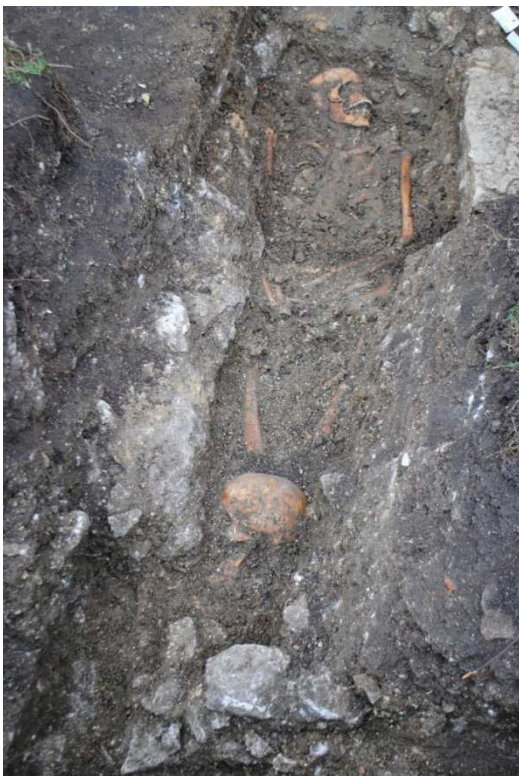
*Figure 44 Selections 1 and 12: looking west*

The rough nature of the buttress foundations seems to match that of the rubbly segment of [1038] as it meets the angle of the buttress. This segment may be bounded on the south by a stone observed to have an un-bonded face running away west under the existing chapel wall.

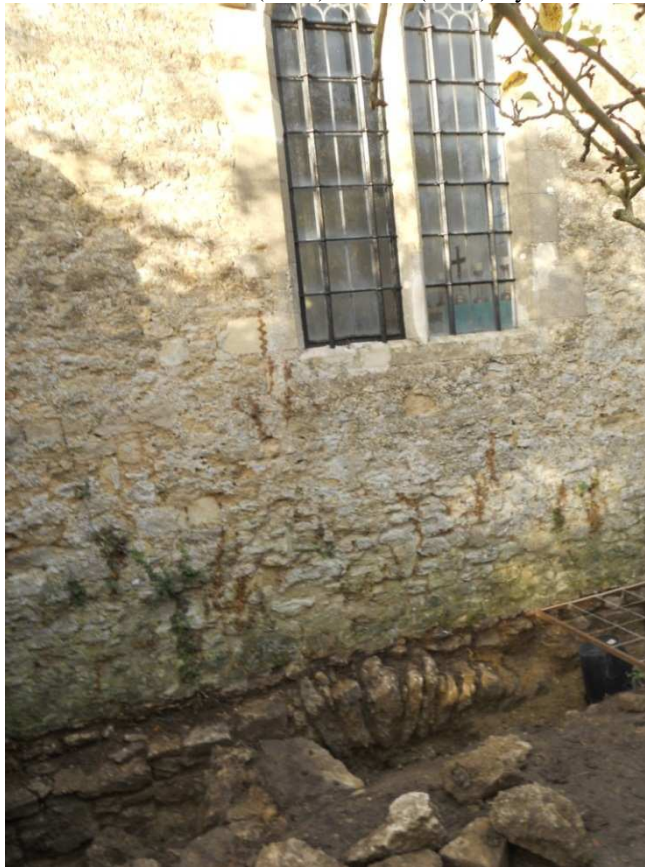
*Figure 45 Sector D: looking NNE*

The much less disturbed layer (1004) below was 0.5m deep and appeared to be the backfill of the original construction trench for the 14<sup>th</sup> century Chapel. The south-facing section of the slot showed the slope of the backfill. No evidence was found of the southern limit of the construction ditch, implying the ditch was originally wider than the trench. A Nuremberg jetton was found at the interface between (1004) and the (1000) layer above.

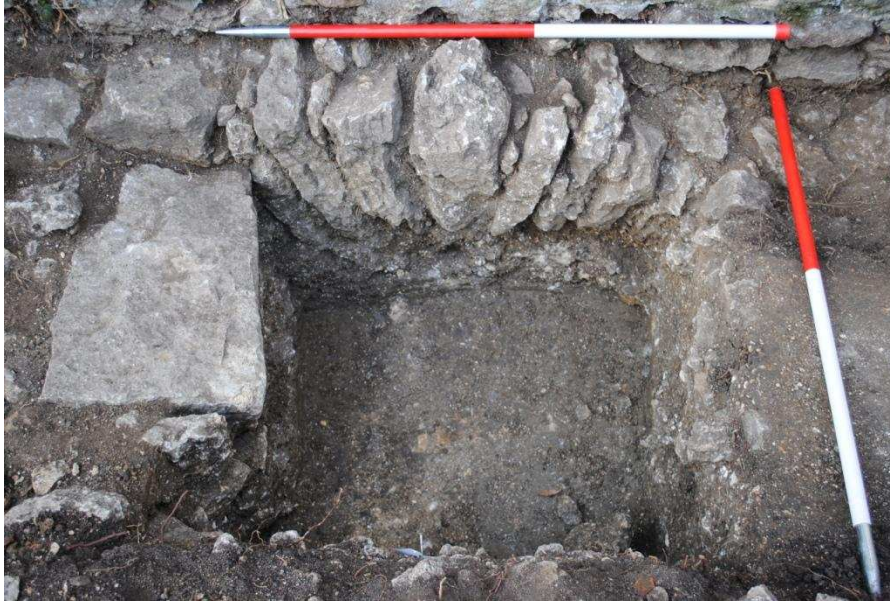
*Figure 46 Relieving arch: looking north*

Sector D between the SE buttress and the south central buttress contained a great deal of structural rubble, some of it finely worked. The excavated area revealed one of the relieving arches in the foundations of the 14<sup>th</sup> century Chapel. Pottery retrieved from the back-fill of the construction trench included 12<sup>th</sup> – 13<sup>th</sup> century roof-tile and earlier Brill ware, while a Nuremberg jetton was found at the change between the more disturbed upper layer and the construction trench back-fill.

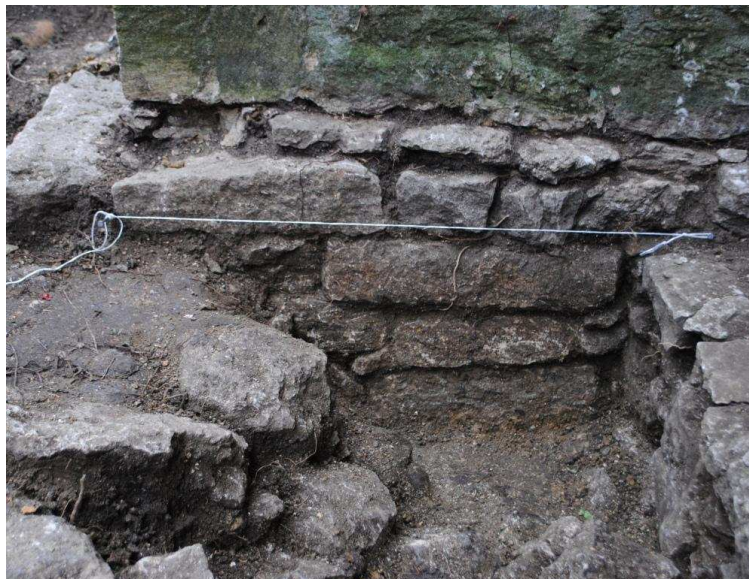
*Figure 47 Central buttress: looking west*

Excavation against eastern side of the central buttress demonstrated the complexity of the history of the Chapel's fabric. Although there were no pre-14<sup>th</sup> century foundations/ wall courses on this southern side the lower stones of the foundations ran behind the buttress indicating that the buttress structure had been largely re-built; the lower courses of the buttress itself were also of a different style and build to the first visible courses.

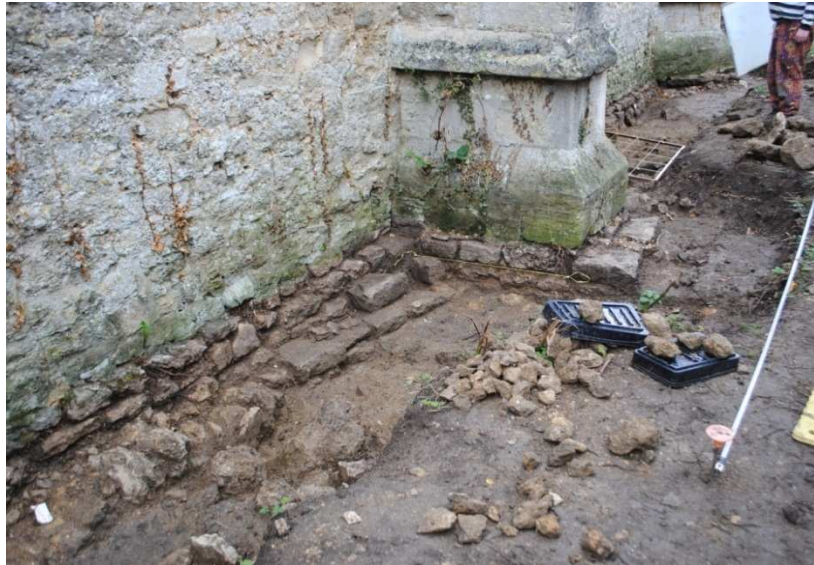
*Figure 48 Sector E under excavation: looking NE*

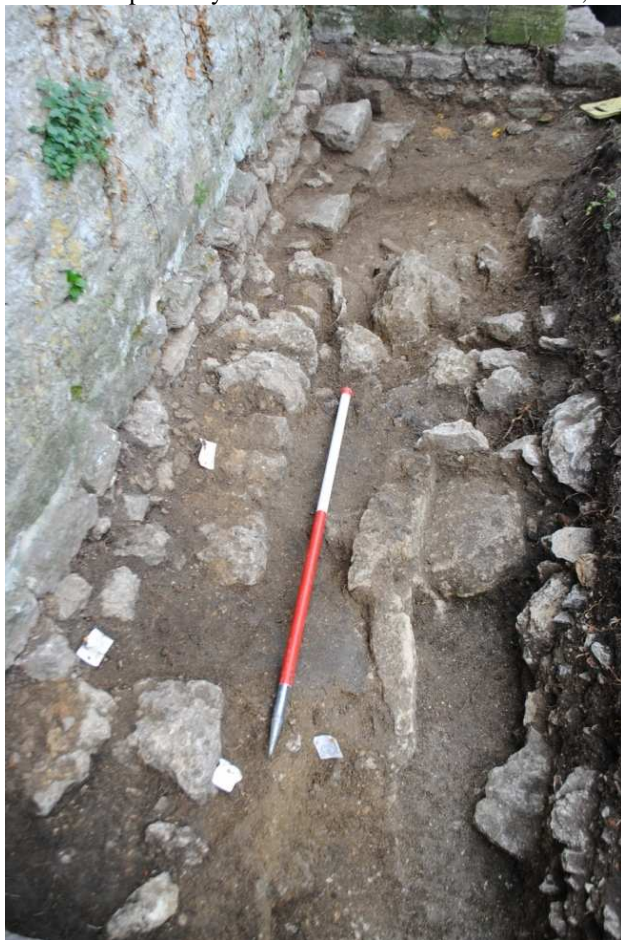
*Figure 49 Stone lined grave [1024] on the right: looking east*

There can be no human bones certainly identified with the original burial. However, there was a stone-lined grave giving an idea of who might have been buried there. Stone-lined grave [1024] lay in an E-W alignment: the original burial will probably have been head in the east end; feet at the west end. Thus if undisturbed the skull may still lie

beneath the ground east of the exposed side of the grave, however modern drainage works cut across this area. The original grave was designed and given a designated area with care and respect: close proximity to the chapel denotes an important person. The original occupant may have been one of the hospital administrators or a chaplain/warden. The chosen place of the grave itself is an important position: in the eaves' drip and on the south side of the chapel (see Plan 1.11).

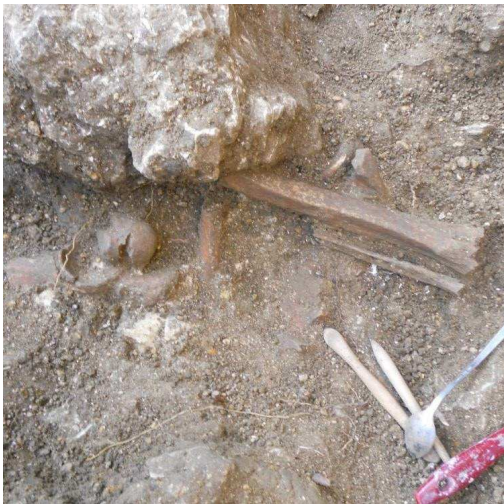
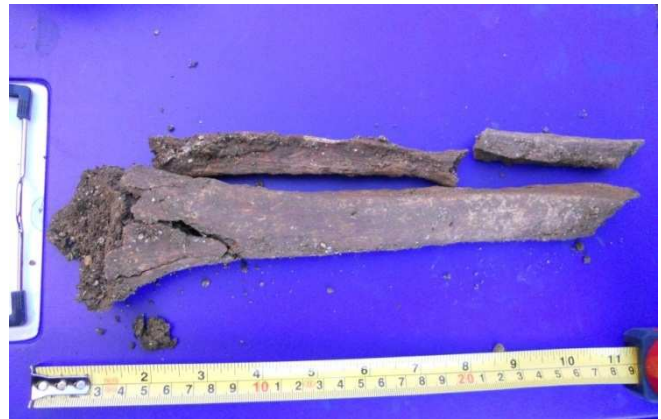
**Figures 50 and 51** Charnel pit under excavation looking south and excavated human bone on the right

Nonetheless, this was clearly a charnel pit designed to bury more than one skeleton together. One may want to know where these skeletons came from. It is likely that they were found on the chapel site either during building works to the ground or in the attempt to clear some space for new burials. Both are possible, as there have been many changes to the site (note of the difference in chapel structure and wall phases, the structure found in Trench 3, and the structures found in Trench 1 near the infant burial). It was common, at least on the European continent, to rebury skeletons in a charnel pit with a greater organisation of bones than has been found here. It was thought a possibility that this charnel pit was also organised by keeping the skulls separated until part of a lower jaw, one or two metacarpals, and one phalange were found (22.10.2011) on the eastern end of the grave next to the north stone structures wall.

There were at least three skeletons in the pit, as three separate pelvises were removed. One pelvis can be seen in Plan 1.6 at the level of 75 and can also be seen by matching above layers with Plans 1.3 and 1.5. Another piece of pelvis can be seen in context record sheet sketch. It is lodged in the west wall whilst the other pieces were lifted. However, there was perhaps a patterning to the grouping of the long and other bones. A mixture of ribs, radiuses, some tibia, and several femurs were grouped together lying, mostly, in an east-west fashion. This can be seen clearly in Plans 1.3, 1.5, 1.6 some vertebrae were also found in this area.

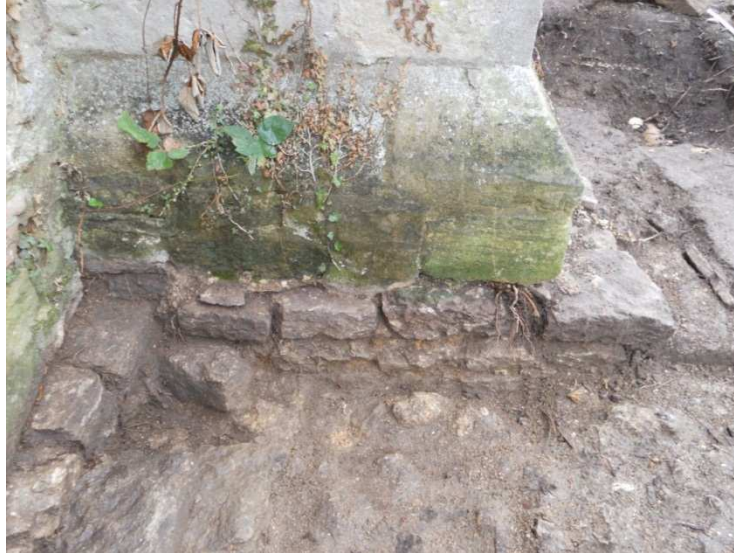
*Figure 52 Central buttress: looking east*

The changes to the chapel could have affected the grave. The relationship to the grave will not be entirely known until the changes to the chapel can be verified and dating of the pit (if possible) compared. However, it is worth noting the changes to the chapel visible in Sector E. There are two phases of wall and one archway. One of the phases to the wall is certainly from an earlier time and lies at a south-east-east angle. The angle can be seen in Plan 1.11 where the wall stones, to the east, at levels 168, 170, and 172 are at an angle distinctive from the above phase at 171 and the arch at levels 164 and 165. It is also worth noting that there is a rubbly area of the wall just above the charnel pit (near the middle of the stone-lined grave if it had been found intact) (Plan 1.11 and sketch from 1051 context record). Perhaps, there is a relationship between the two, but it is not known at this time.

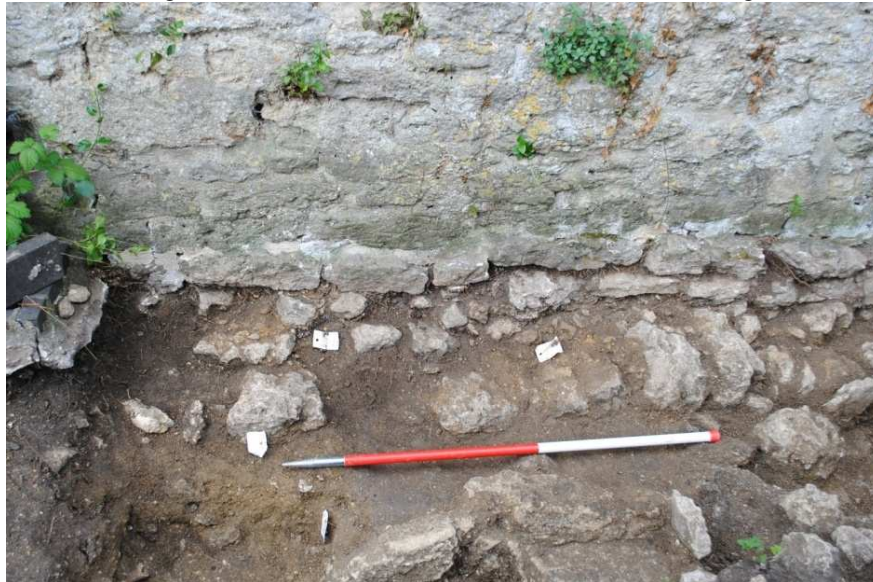
*Figure 53 Sector E under excavation the top stops of a relieving arch are visible in centre right: looking north*

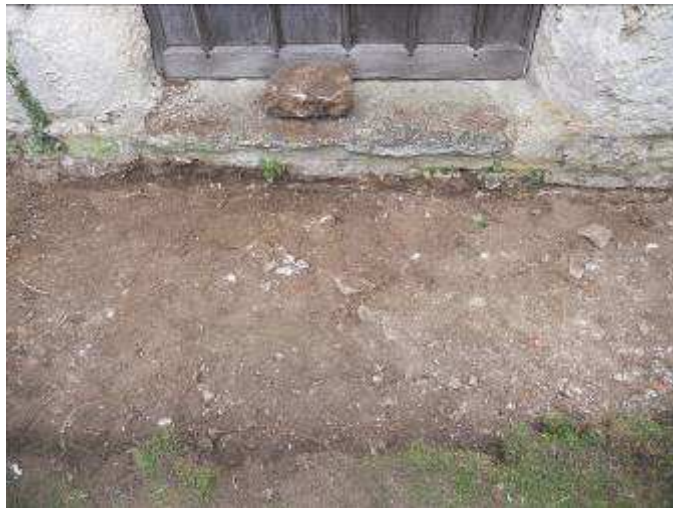
**Figure 54** The central section of Sector F at the threshold of the W door. (1000) Digger context extends to N (left) round NW chapel buttress and to S (right) round SW buttress; note the substantial stone step to W door and stone coursework revealed on removal of (1000)

Between 0.1- 0.2m below topsoil was removed from the whole 6m x 1m west gable end sector with the small mechanical digger. The context was friable, dark greyish brown slightly sandy silt - somewhat gritty, becoming increasingly stony and tightly-packed with depth. Inclusions were mainly limestone rubble (max size 0.1m) with occasional CBM. Towards the SW corner the content of large pieces of limestone rubble was 50%, occasionally worked; at the NW corner there was much more disturbance due to yew roots and drainpipes with more worked stone. Finds included pieces of pottery, glass and clay pipes.

The context is interpreted as the deep make-up layers/construction trench back-fill building up from the foundations of possibly an earlier chapel build, to the current level of the W door.

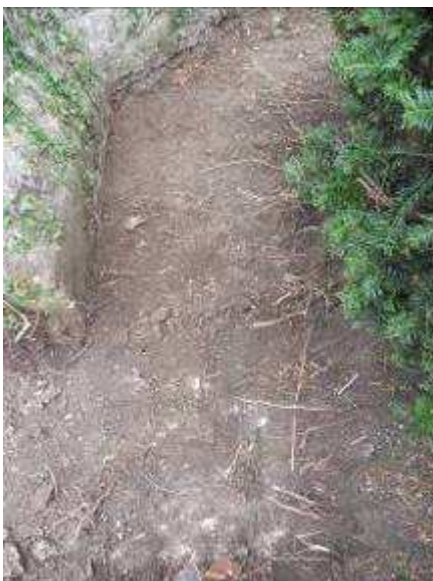
**Figure 55** Rounding NW buttress in Sector F – (1000) Digger removed; note Yew tree

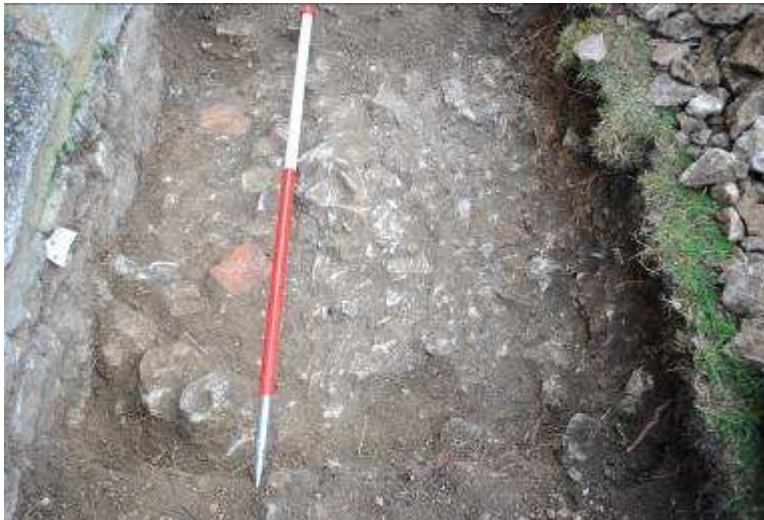
*Figure 56* After (1019) removed, showing make-up of lower layer (1028); note the large stone threshold step to chapel W door (top left of photo). Also the cut stone courses of structure [1048] being revealed as layers of compacted rubble removed in metre square slot.

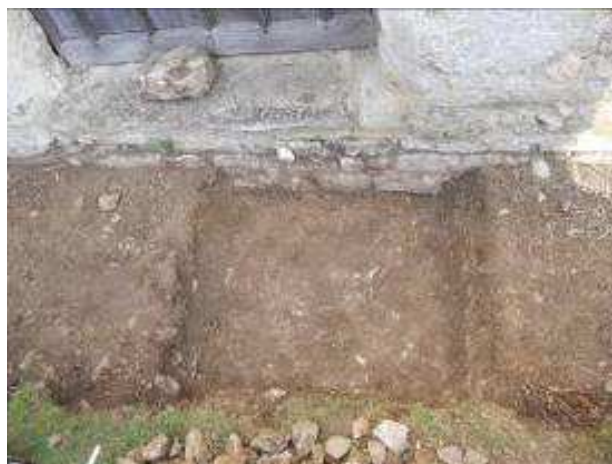
*Figure 57* (1028) having been removed, the worked stone courses of masonry [1048] onto which the W elevation of the present-day chapel sits is seen to be of different stone: substantial dressed cut slabs.

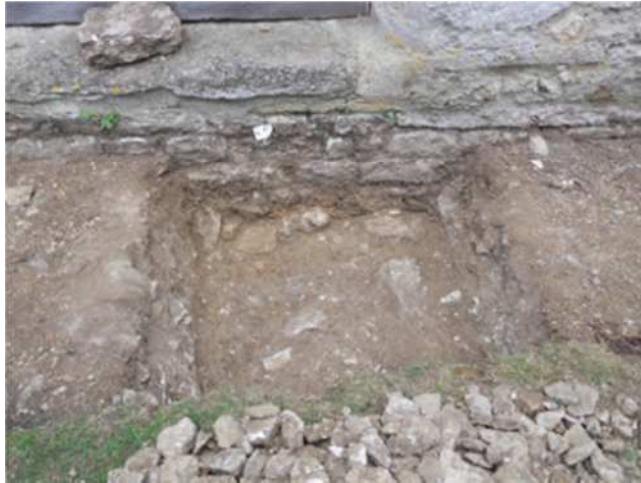
*Figure 58 (1032) having been removed*

A further 0.1m layer removed under (1028) clearly revealed three dressed stone courses of masonry at a depth of c 0.4m beneath the chapel W door step. The context, similar to (1019) and (1028), was made up of tightly packed limestone rubble (60%), pebbles (20%) and gritty mid brown sandy silt (particularly adjacent to wall), but also, at this lower level, 2% clay. The loose friable strip 0.1-0.9m by W door was still evident and a small amount of (animal) bone fragments (3%) was found.

For interpretation see (1019) and (1028) above. It is thought that the fine stone coursework under the W door threshold might well be an earlier chapel wall.

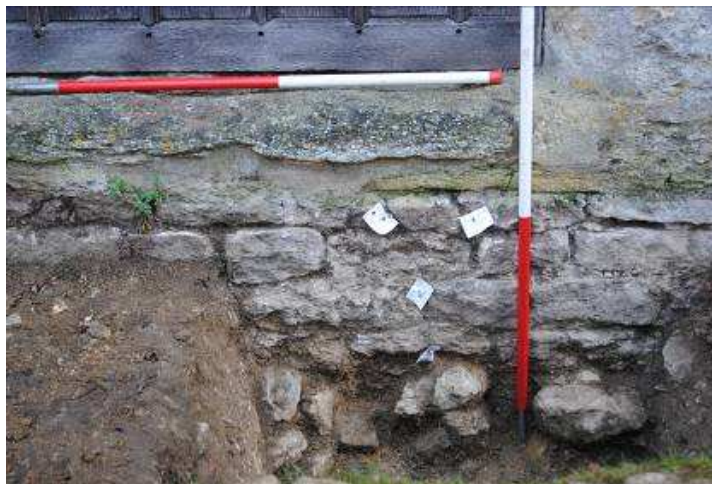
*Figure 59 The line of large rough stones revealed (bottom of photo) over the clay base of 1m slot seems to indicate an earlier phase under the previously revealed three courses of dressed stonework beneath the existing chapel W door.*

The composition of this c.0.2m deep context altered with depth. Under the upper level of limestone rubble (70%) and gritty sandy silt there was increasingly more clay (10%). Finds also increased to include numerous pieces of high quality dark to lighter shades of green glazed pottery, numerous fragments of glass and charcoal in the clay base. This change in context coincided with the appearance of a course(s) of large rough stones on the clay base, jutting 0.1+m proud from under the 3 revealed courses of dressed stonework of [1048].

Layers (1019), (1028) and (1032) produced only small amounts of finds in comparison to (1035), leading to the suggestion that the level of this course of large rough stones under (providing a foundation for) [1048], might be an original external ground level. The finds of pottery could be linked to the Civil War occupation by Cromwell's troops – perhaps pieces from drinking vessels from the alehouse opposite? (The present-day Farmhouse was rented out as an alehouse to a Mr George Prince in 1645 and would have presumably provided for the troops).

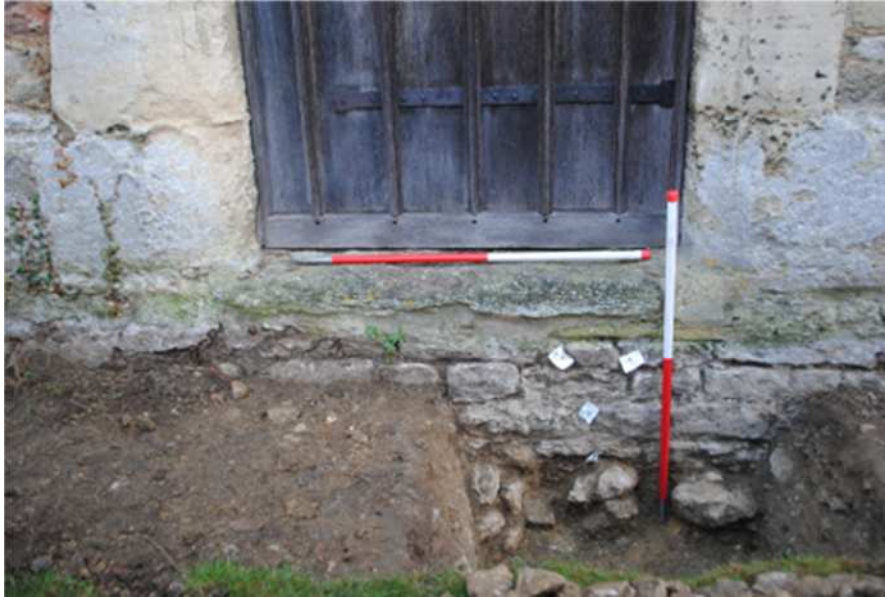
**Figure 60** 1m length of Structure [1048] off set to S (right) of Chapel W door. Upper 4+ dressed stone courses visible beneath the stone door step. The lower 2+ rough cut courses are set into clay.

Centred on (11.2, 15.25), lying N-S between the existing NW and SW buttresses, the whole revealed structure [1048] measures 1m long x 0.6+m deep, and is situated beneath the chapel W door step, slightly offset to S. The door step is bedded into cement/lime mortar onto its top course. It is probable that a similar pattern of coursework continues E and W under the length of the chapel west gable wall between its two buttresses. The upper 4/5 courses of [1048], up to the W door step, are of regular (but uneven) courses of cut and dressed stonework (possibly 2 different types of limestone) bonded in lime mortar. The lower 1+ courses, 0.2+m in height, revealed by removal of (1035), are of random rough cut stone sitting on the clay base 0.6m below existing ground level.

The lower rough cut courses could be interpreted as earlier chapel foundations onto which a later model has been built. The existing chapel W wall, which is built into what appear to be courses (perhaps the 14<sup>th</sup> century Oriol College built chapel) rather than foundations, suggests a reconfiguration or rebuilding, perhaps in the 17<sup>th</sup> century after the substantial damage caused during the Civil War, of the W entrance, as do remains of what appears to be evidence of an earlier segmental arch above the existing chapel door. Most of the finds were discovered at the level (approx 0.4m below the existing ground level) where the rough and dressed cut stone courses meet. Perhaps this marked an earlier ground surface.

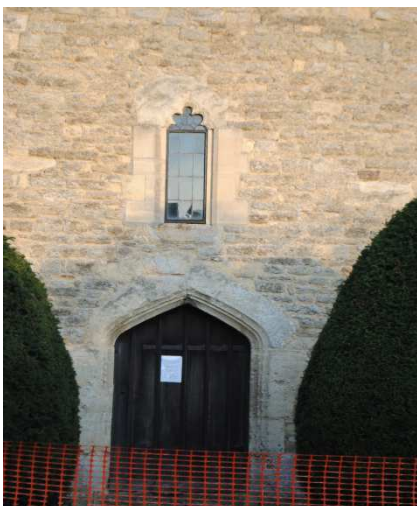
**Figure 61** W wall of existing chapel showing W doorway with moulded jambs and segmental pointed head thought to be late 14<sup>th</sup> century? But why is there clear evidence above its head (to N/left) of half the remains of an earlier segmental arch?

However the W doorway is widely held to be 14<sup>th</sup> century: there is a similar 14<sup>th</sup> century doorway in Magdalen College which is at odds with the clear evidence of an earlier segmental arch above it. Also there is clear evidence above the small W window of the raising of the gable end to 60 degrees above the original 35 degree parapet, in order to hang Cotswold tiles; the original shallow pitched roof having been stripped of its lead by Cromwell's troop for the manufacture of lead shot.

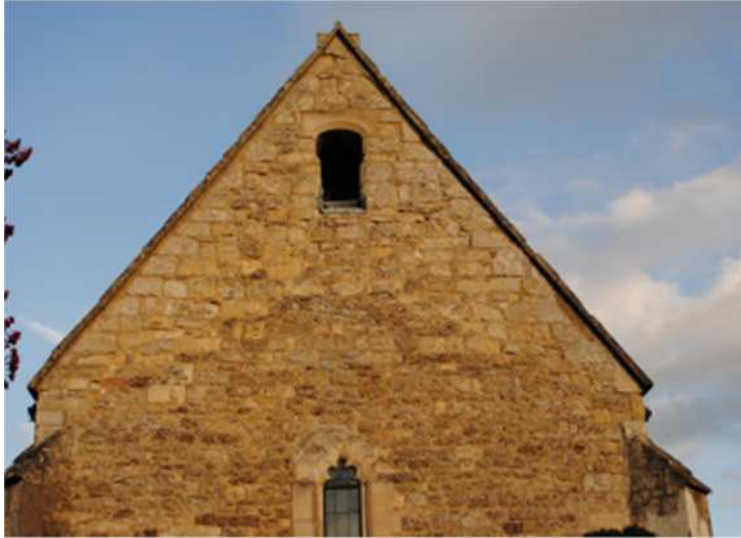
*Figure 62* W gable end of chapel; the change in stonework showing clearly the raising of the chapel roof after the Civil War to give a 60 degree pitch to accommodate the hanging of a Cotswold tile roof
