BC11 Trench: (1000) removed by machine

Structure [1036]

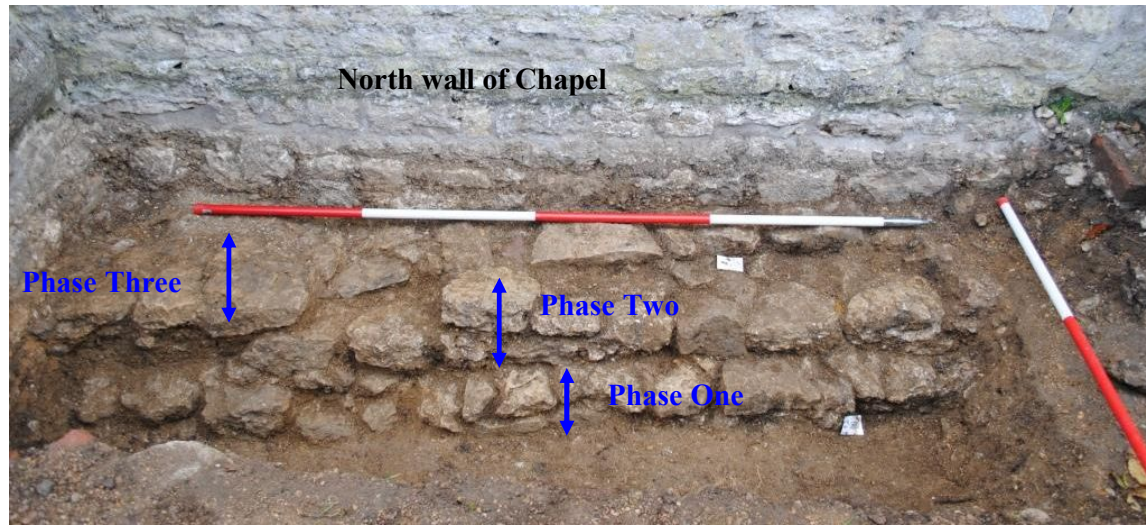
This consists of one course c. 0.07 m high, and includes 3 large ‘flags’ over the ‘missing’ upper course of Phase 2 (E end of structure). This course comprises the roughly curved line of stones Plan 1.7. In Elevation 102, the front edge of Phase 2 partially obscures Phase 3.

This phase continues in the west-facing section beneath the buttress (see photo and 101).

Above Phase 3 are 2-3 courses of the N wall of the extant chapel, partially obscured by liberal application of ‘modern’ grey cement, presumably to support original crumbling mortar.

Two or three structural phases were visible below the existing chapel wall: see Plan 1.7 and Elevation 102, drawings and sketches on context sheets.

Two courses: with a total height of c. 0.13 m. These are more regular than Phase 1, with a smaller size range and appearing more squared, suggesting greater care in fitting and finishing. There is an area on the exposed E side where the upper course is missing.
