Bartlemas Chapel Excavations: Trench 1

Trench 1 Introduction and Summary

Trench 1: Excavation Report

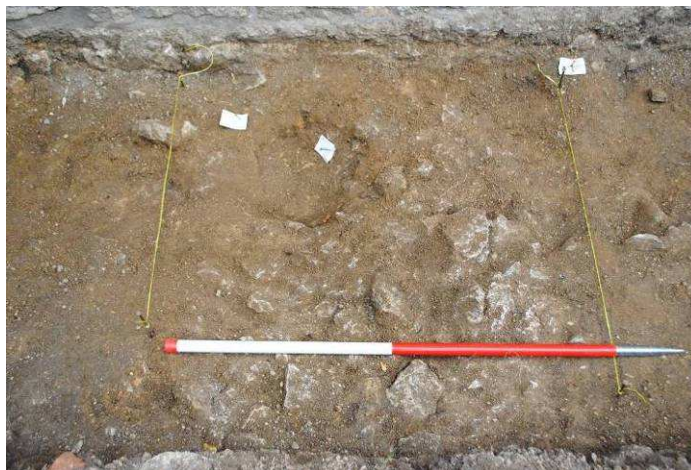
Figure 1 Post-hole for scaffolding in Sector A, following removal of fill (1013) from cut [1012]; also showing limestone rubble inclusions of (1000)/ (1014) in foreground.

Removal of layer (1000) proceeded using a trowel. This was mid-brownish yellow sandy silt with lenses more rich in sand and clay, degraded mortar and drainage grit. Inclusions of limestone rubble were notable (see Fig. 1), especially towards the drain, with a few broken slabs up to 0.3 m long. Bulk finds were scant, including clay pipe fragments, pottery sherds and animal bones.

Layer (1014) was first dug in an approx. 1 x 1 m square (see Fig. 1), but was subsequently extended westwards towards the drain, exposing the edge of the masonry courses (see [1036]). The east-west extent was almost 3 m. Finds were scant and included a small red glass bead, and a fragment of early mediaeval pottery. The limestone rubble in this layer included several wedge-shaped stones, up to 0.2 m (longest dimension) and 0.05-0.1 m thick. Many seemed set point up in the context in short rows. Patches of degraded mortar adhering to the stones suggested a purposeful design. However, as (1014) was excavated, this idea was discarded and these stones were interpreted as small wedge-shaped infillers that had fallen from earlier upstanding masonry, from which larger blocks of dressed stone could have been reused (Fig. 3).

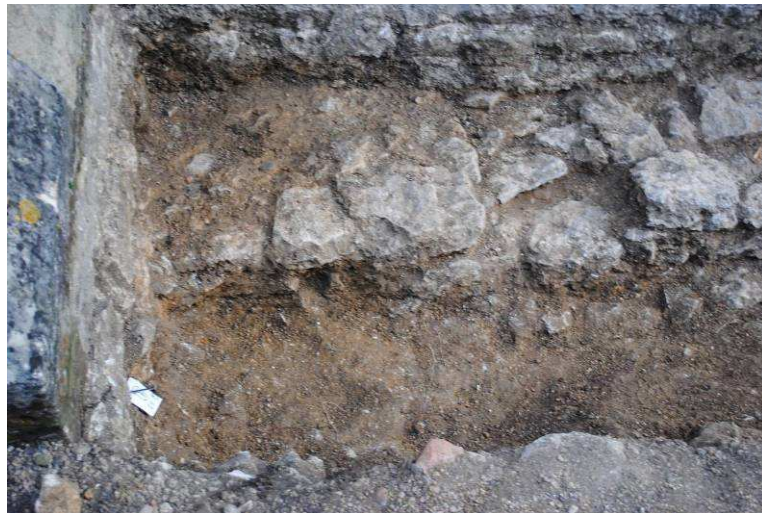
Figure 2 Showing the two patches of reddish decayed mortar (1021). The large flag at the centre belongs to the upper course of [1036], the edge of which seems to curve to the right.

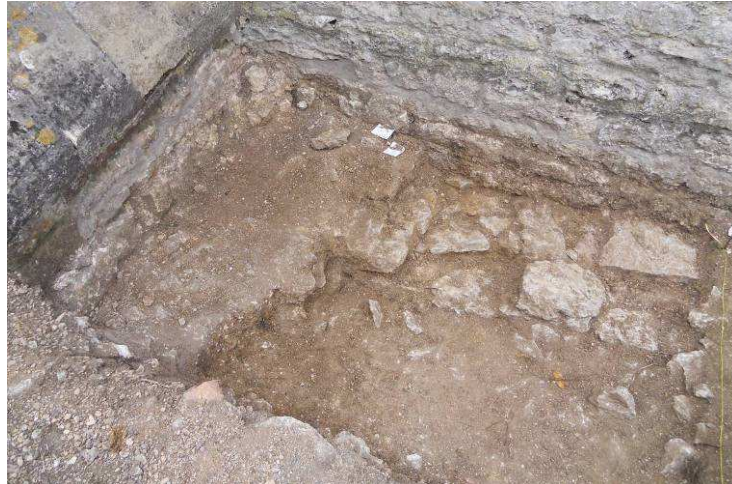
Figure 3 Phase 2 of [1036] emerges from (1014), centre right. Small upright wedge-shaped infillers can be seen in the unexcavated context.

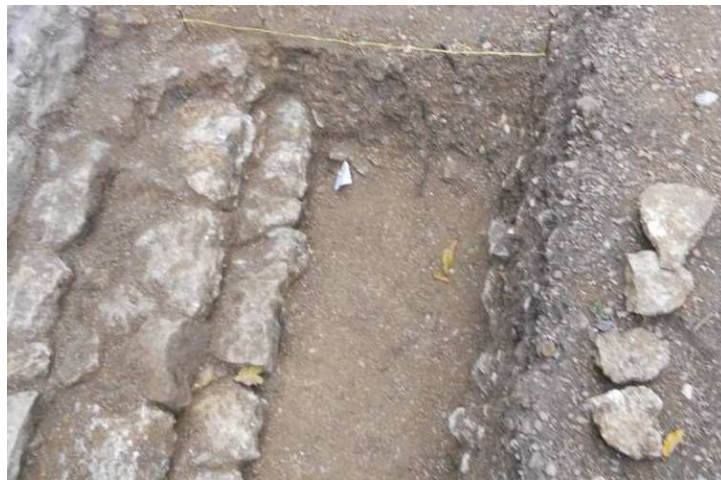
Figure 4 The three steps of [1036], looking west, north chapel wall on the left. In the right foreground are examples of the wedge-shaped infillers.

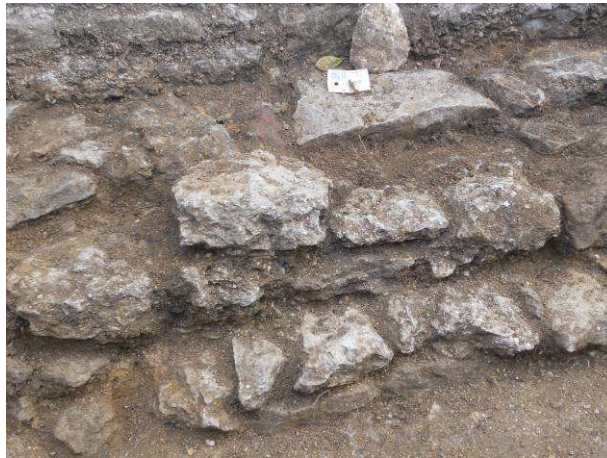
Figure 5 North-facing section showing the phases of [1036]: Phase 1 (lowest), 2 courses; Phase 2 (middle), 2 courses; Phase 3 (upper, slightly recessed), one course of larger flags.

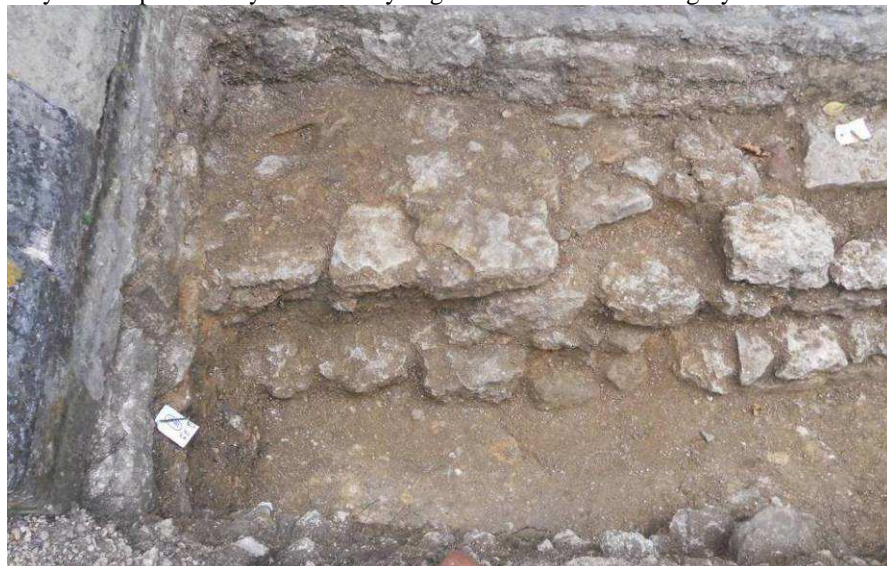
Figure 6 Eastern area of Sector A, showing the three phases of [1036] adjacent to the northern buttress. Note the area of soil below the three large flags of Phase 3 (centre left) where the upper course of Phase 2 has been lost.

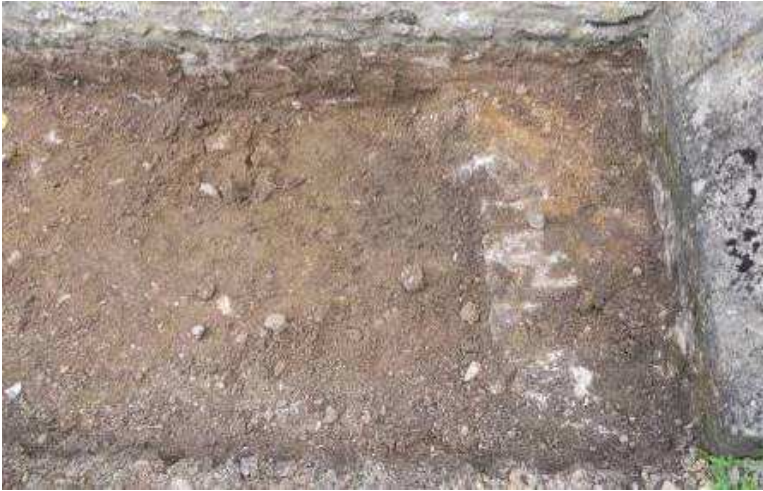
Figure 7 Structure [1045] to W of existing N chapel buttress appearing. Patch of darker earth to SW of [1045] later to reveal posthole fill (1003)/cut [1005]. All figures looking south

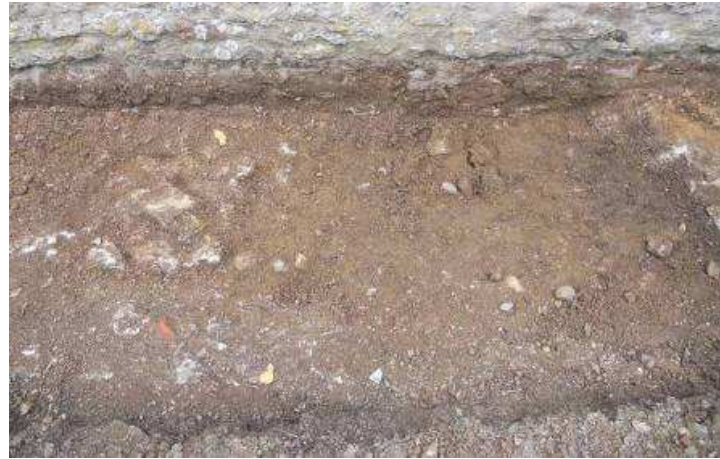
Figure 8 Structure [1037] appearing to E next to chapel wall. Dark earth still visible to W next to [1045]

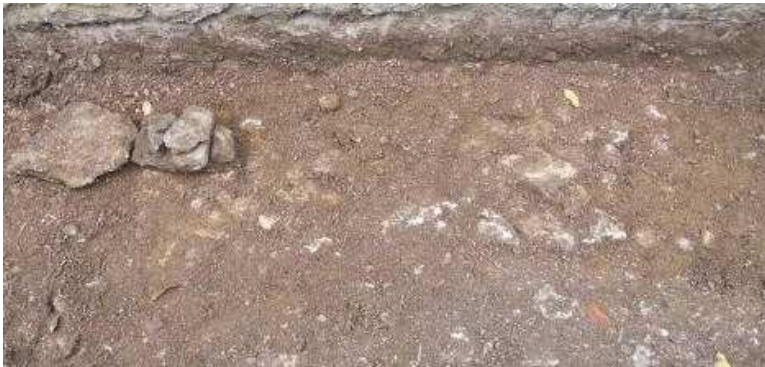
Figure 9 Moving E, more of [1037] becoming evident

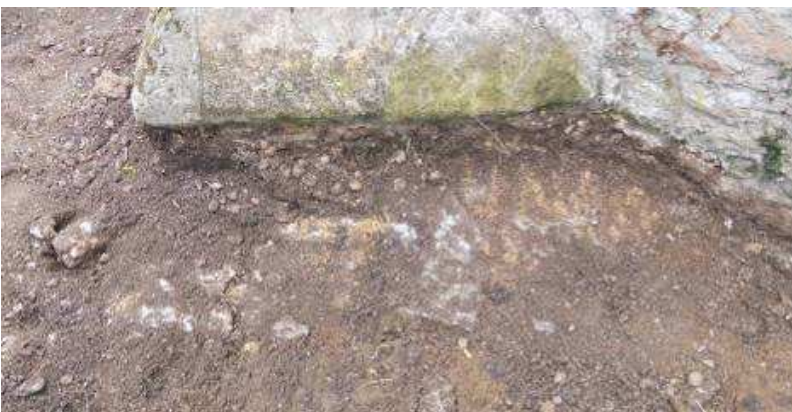
Figure 10 Structure [1044] becoming visible to W of NE chapel buttress

This interpretation is backed up by the other revealed separate (not tied-in) structures (buttresses foundations) built directly over [1037] which themselves run independently under the existing chapel: [1044] to the E and [1045] to the W. It is possible that the substantial buttresses might be vestiges of Oriel College's 14th century chapel replacement, built after their acquisition of the Hospital Foundation land and buildings in 1348/9. The existing chapel could therefore be the Oriel 17th century part rebuild, part thorough restoration, undertaken after the Civil War (the 14th century chapel having been 'ruinated almost to the ground': A. Wood). The north window (see Fig. 10), however, is thought to be original 14th century.

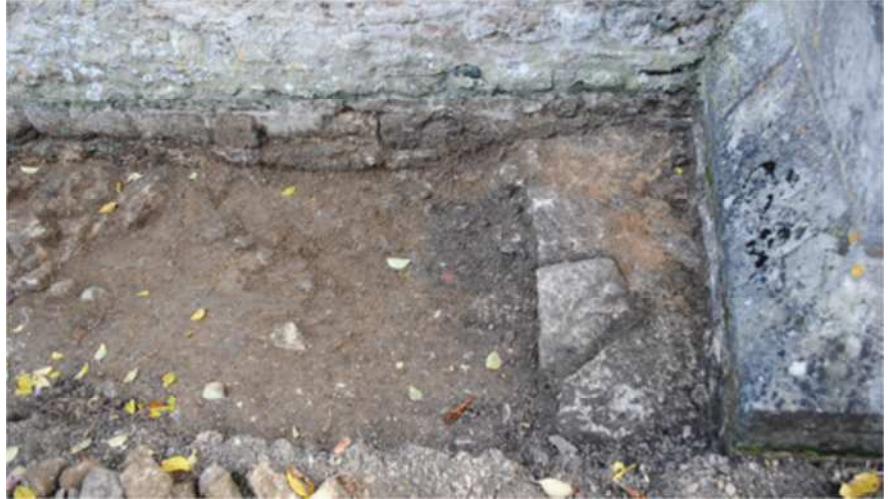
Figure 11 Substantial flagstones of [1045] revealed in W at foot of N buttress. To E, stone course of [1037] becoming clear: note the earth gap in between; [1045] runs under the chapel N wall and buttress.

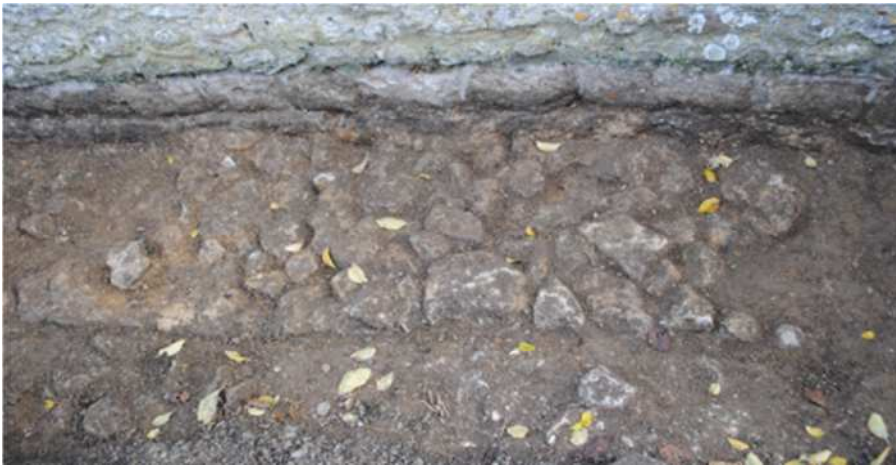
Figure 12 Further E, upper stone course of [1037] becoming clearly visible, the loose rubble layer having been removed by hand: the 2 lower courses of the chapel N wall have been revealed and [1037] runs under.

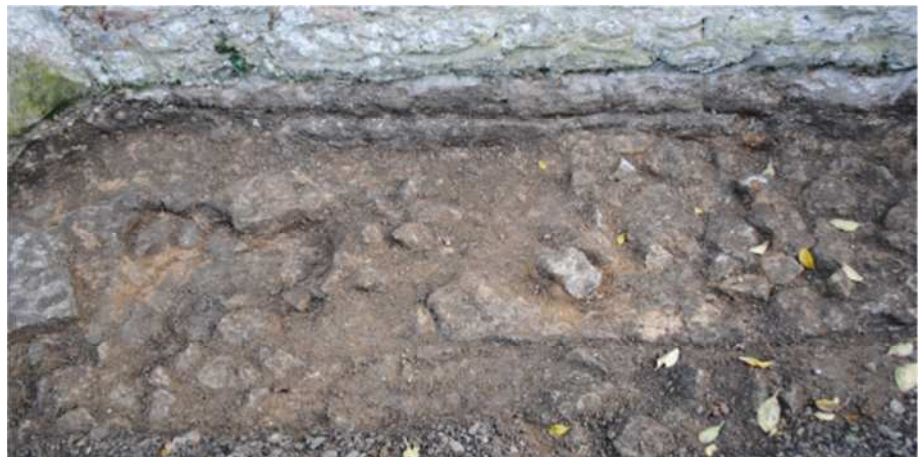
Figure 13 Large flagstones of [1044] visible to E (left of photo) near angle of chapel wall with NE buttress; note post hole semi-circular cut.

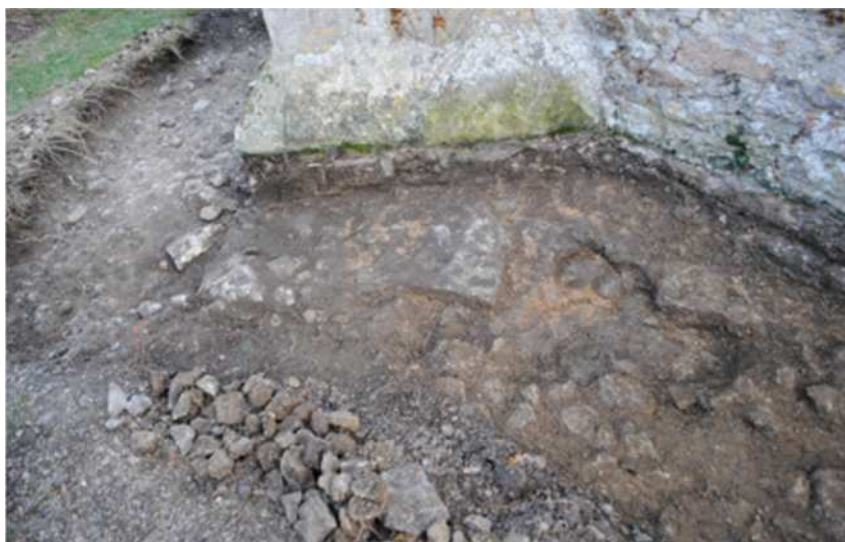
Figure 14 Eastern end of [1044] at foot of NE buttress; substantial flagstones becoming visible: south round buttress NE corner flagstones disappear: major disturbance/tumble in this area.

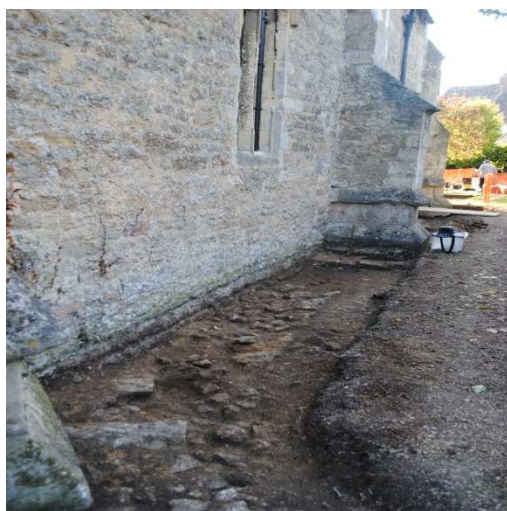
Figure 15 Looking W along Sector B: [1044] in foreground; [1037] in centre of context: [1045] visible at foot of N buttress

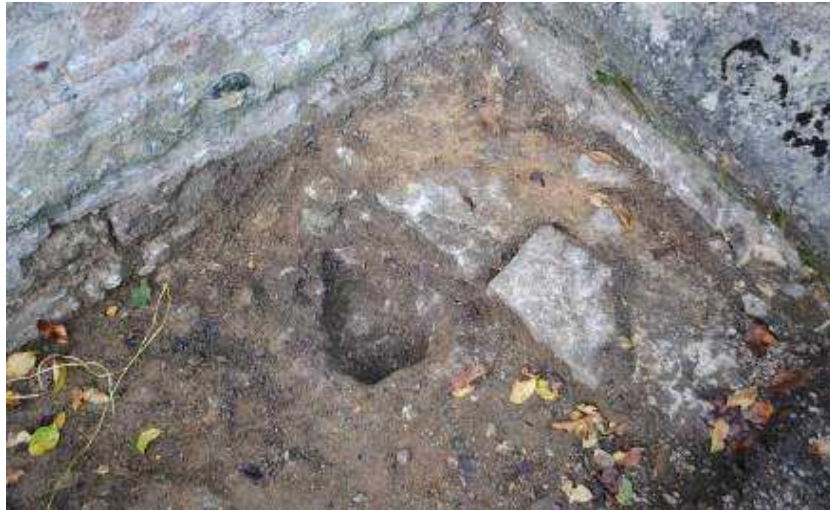
Figure 16 Cut [1005], fill (1003) removed: flagstones of [1045] to east of north buttress clearly visible.

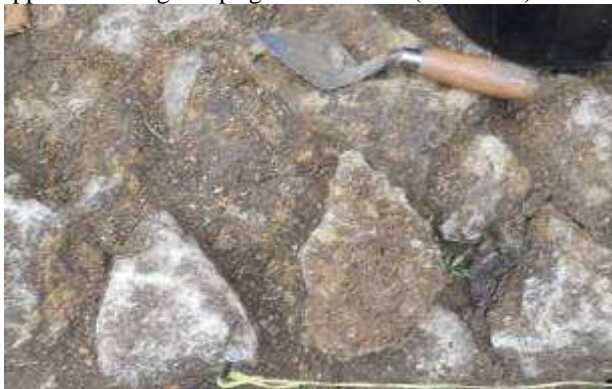
Figure 17 Wedge-shaped infillers within (1006).

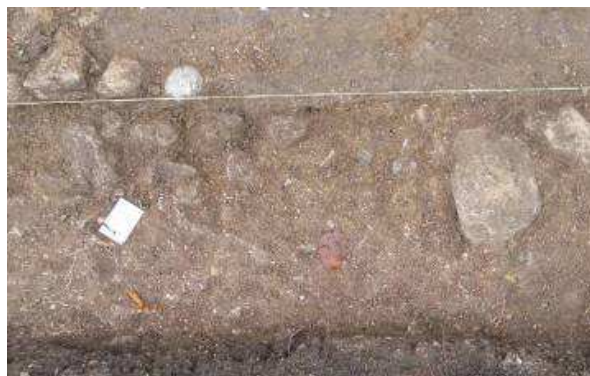
Figure 18 During removal of upper 0.2 m of (1008) showing the gap in [1037] above and right (west) of the string. The gryphea fossil is the bright white round object left of centre, and the worked stone (SF 38) is emerging on the extreme left just below the string

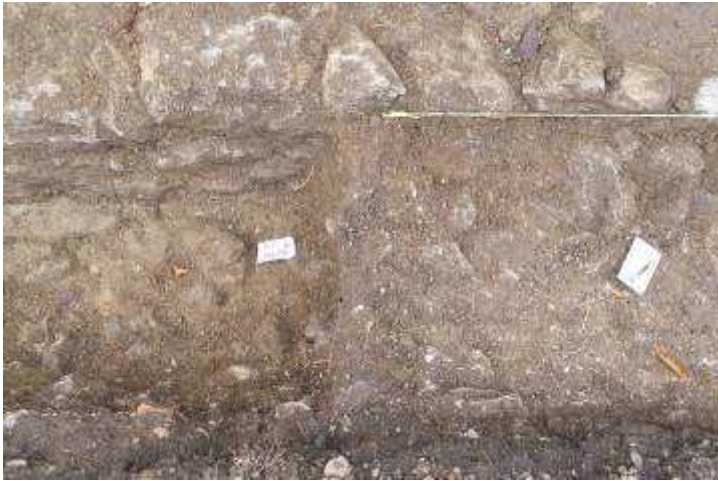
Figure 19 During removal of (1008) to the right (West) and after removal of (1006) to the left (east): the masonry courses of [1037] are becoming clearer: it becomes apparent that the courses are at a slightly different alignment E-W to the chapel north wall.

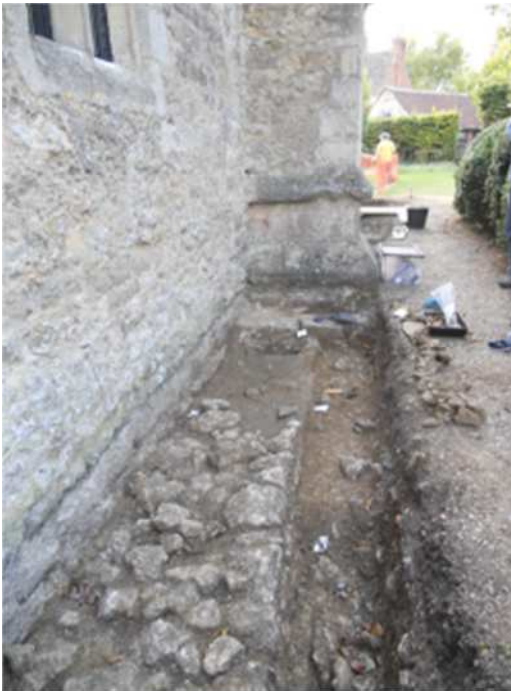
Figure 20 To north of [1037] and south of path, E and W sections of layer (1008) extending trench from (1006) in foreground to [1045] in W at foot of N buttress

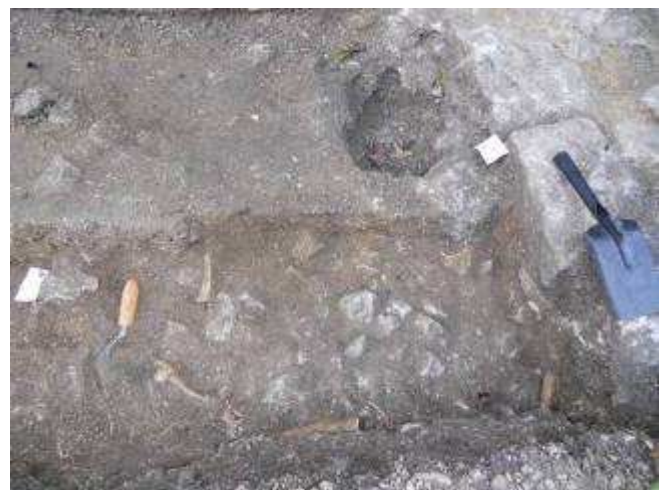
Figure 21 Western section of (1008) abutting [1045], before excavation of L-shaped southern section around posthole cut [1005]

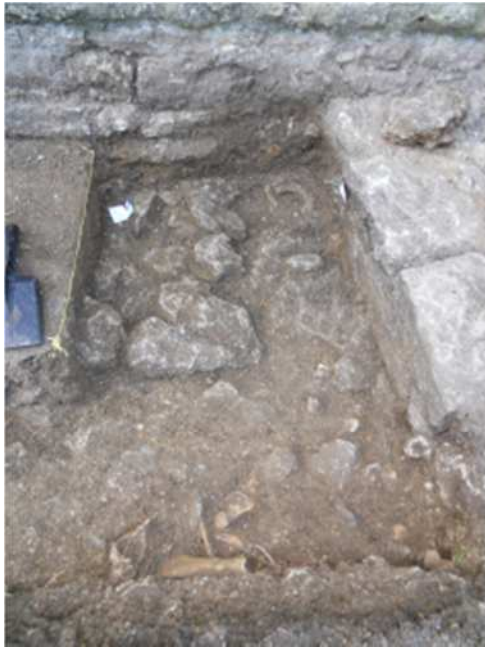
Figure 22 Layer (1020) having been removed to S, the W end lower course of [1037] stonework is revealed. Context next to the chapel wall is very damp - darker earth colour in photo; note the semi-circular cut in the stone in the angle of the chapel wall and [1045]. To the N further evidence of bones as charnel pit is revealed (for which (1020) was disturbed top-fill. Pot handle can just be seen towards right-hand corner of photo lying diagonally SE-NW. The substantial flagstone courses of Structure [1045] are further revealed to W.

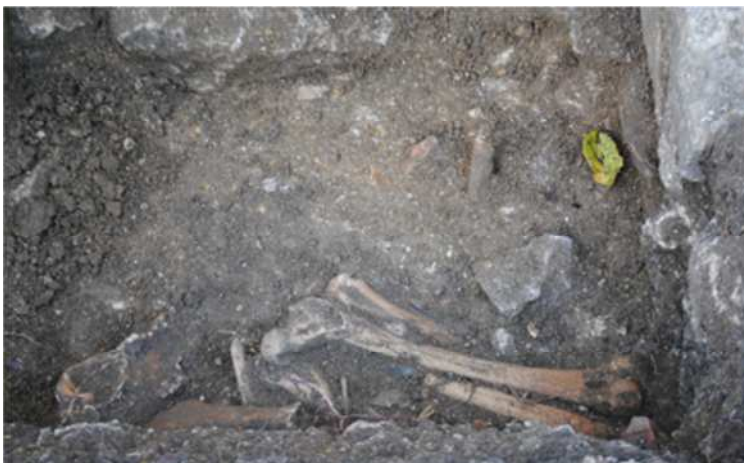
Figure 23 Upper level of (1026) has been removed revealing a jumble of bones within a pit contained between structures [1045] to W (right of photo) and [1037] to S (top). To E (left) the profile is slowly appearing and to N (bottom) it is clear that the pit continues under the path. Dog upper jaw/other animal bone to E (left) with human bones to W (right).

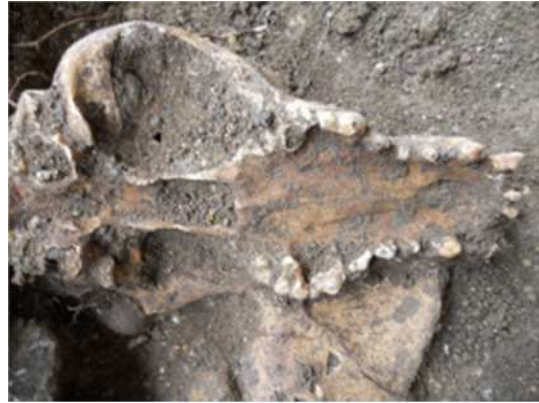
Figure 24 Dog's skull in fill (1026) lying over human Pelvis

Under the rubble layer was a fairly substantial Charnel pit (with a top layer of randomly thrown together animal and human bones, including a well preserved dog's skull with some teeth intact).

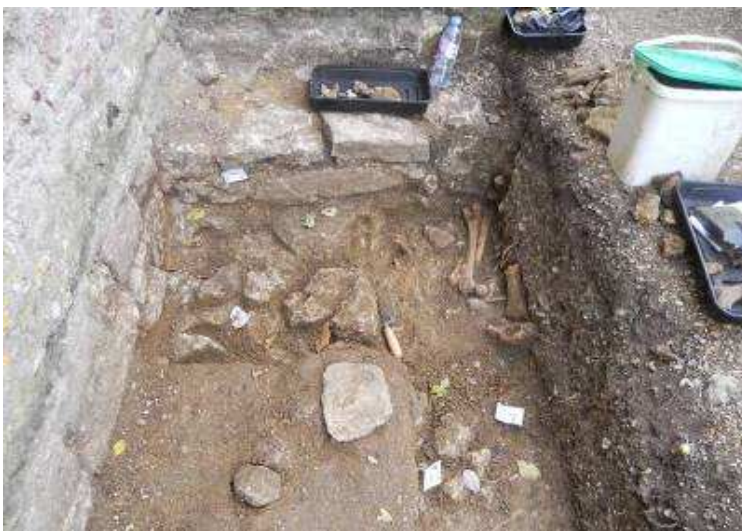
Figure 25 Position of Pit: Chapel wall to South (left), path to North (right); charnel pit (1026)/[1027] to N of W end of [1037], to W of excavated layer (1025); substantial dressed stone courses of [1045] to W (top of picture).

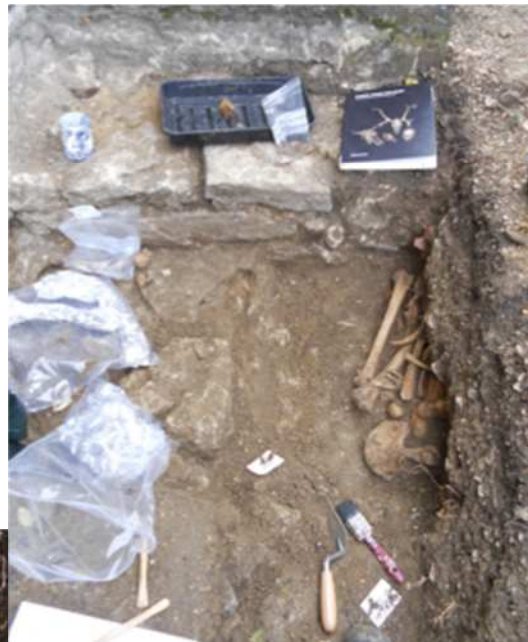
Figure 26 Second level of (1026) has been removed. Dog's skull has been lifted (revealing a human right pelvis), wrapped in foil and bagged, as have other animal and human bones.

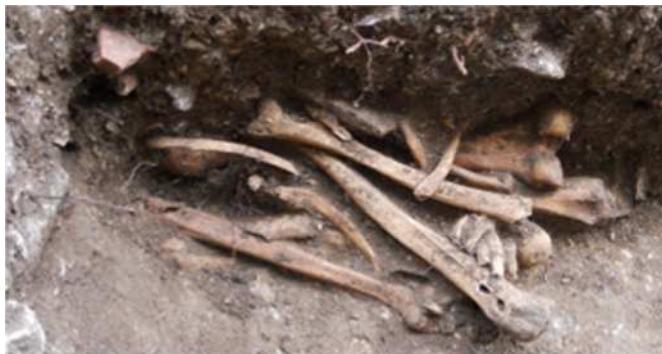
Figure 27 Lower level of Fill (1026) - human bones in path bank

At deeper level in the damper earth there are well preserved intact human bones (most fairly substantial), which although are not articulated, increasingly at lower level have been purposefully lain neatly E-W. The layers of human bone are seen to continue into the N 'wall' of cut [1027] and continue under the chapel path.

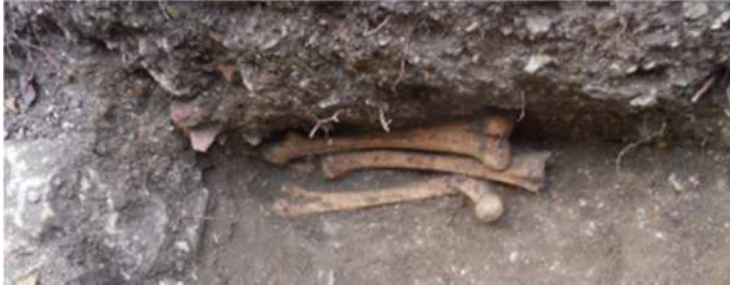
Figure 28 E-W lying human bones in Fill (1026), including more hidden bones continuing N into the bank of the path (see photos in [1027] below), have been well preserved at lower level in the damper earth.

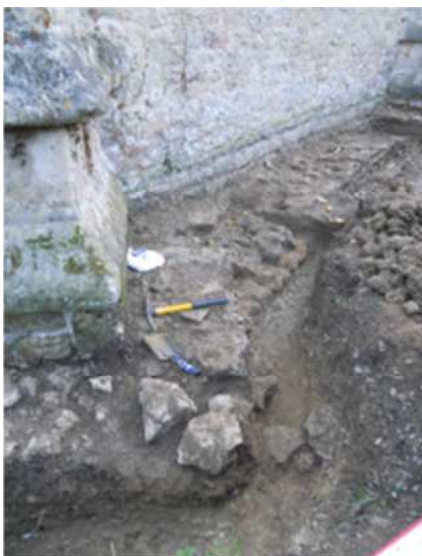
Figure 29 layer (1033) (continuing eastwards from E of (1006)), lies to N of [1037] and to S of path and continues round NE buttress and [1044] into Sector A. The wet clay base of trench to W changes to drier grittier soil rounding buttress to NE and tumble of [1044]. Note possible wall footings in trench as it rounds NE corner. Further jutting substantial lower course stones of [1037] are increasingly revealed westwards.

There was greater disturbance/tumble of the structures [1037] and [1044] in the E/NE section of (1033); rounding the NE buttress corner the clay at lower level gives way to a more compacted rubble mix. And at the corner of the NE buttress there is some evidence of a wall footing and possible floor tiling running N under path.

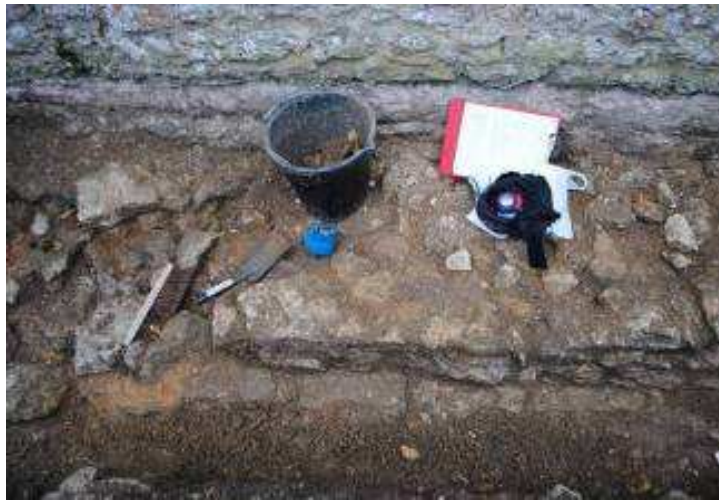
Figure 30 On removal of (1033) further evidence of the jutting lower stones course of [1037] continues to appear; note disturbed/tumble of [1044] to E (left of photo)

[1037]'s condition is patchy; to the west, (before it meets [1045]) a substantial width of the top course of stonework was missing/ removed, and to the east (before it meets [1044]) its courses were disturbed/have tumbled. What is evident however is that [1037] runs under the existing chapel north wall, and also, at lower level, under the substantially larger flagstone courses of structure [1045] to the West and those of structure [1044] to the East. Then, having run under [1045] and the central N chapel buttress, [1037] reappears further west as [1036] in Sector A; similarly, having run under [1044] and the NE chapel buttress, [1037] seems to right-angle southwards before reappearing running N-S as [1038] in Sector C. (See Fig. 30).

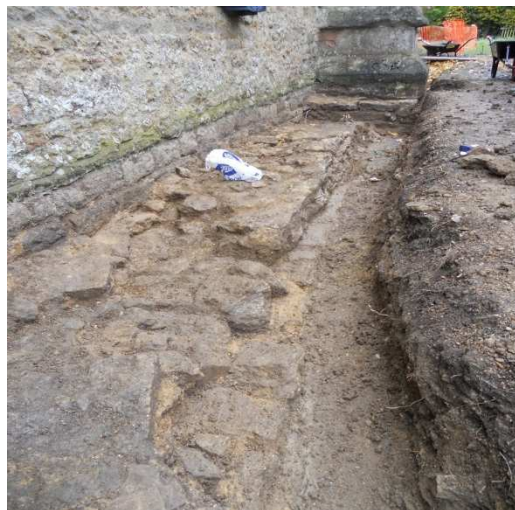
Figure 31 layer (1033) fully excavated to W towards N buttress. Slabs of [1044] clearly visible in foreground to S (left of photo). [1037] with clearly visible lower course of jutting stones (footings) running W towards [1045] whose substantial flag courses can be seen clearly at the foot of N buttress in W (top of photo).

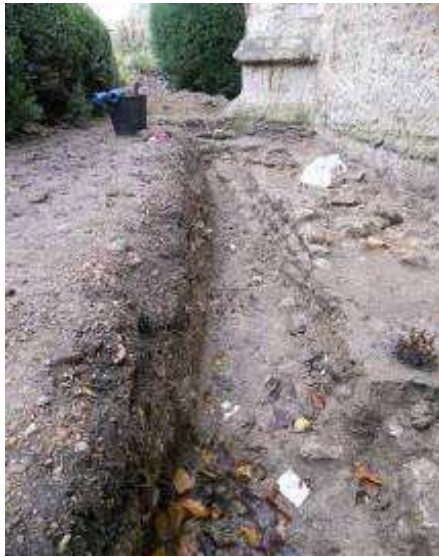
Figure 32 Looking E towards NE buttress, the north-facing edge of the stone courses of [1037] can be clearly seen. See also above Fig. 26 (looking W) and Fig. 25 (footings). The substantial jutting 'footings' are visible to E before [1037] is seen to run under [1044]; also the section of the top course of [1037] missing/ removed further to W, with lower courses revealed (bottom right hand corner) as [1037] continues W.

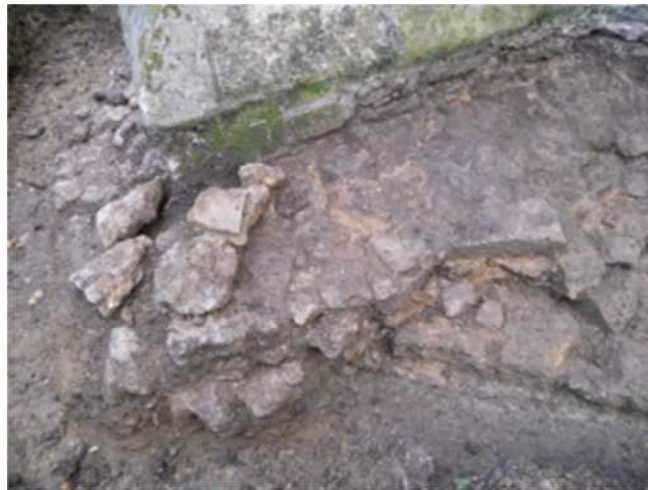
Figure 33 Stone courses of [1037] are seen to run under more substantial flags of [1044] which in turn run under NE buttress.

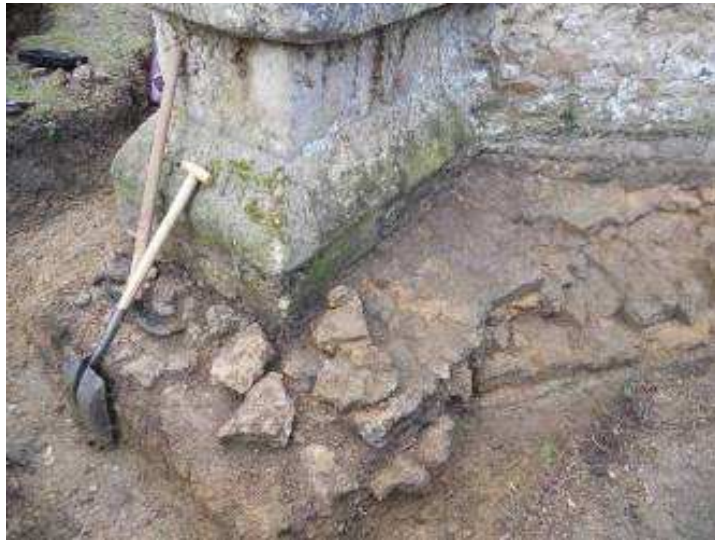
Figure 34 Flags of [1044] can be seen to NW of NE chapel buttress; the state of this structure is patchy due to disturbance/tumble particularly to the NE corner. However, the flags of [1044] can be seen to run under the NE buttress (and chapel wall at angle with buttress) and over the E end of [1037; note posthole cut/tumble in flag near angle of buttress and wall.

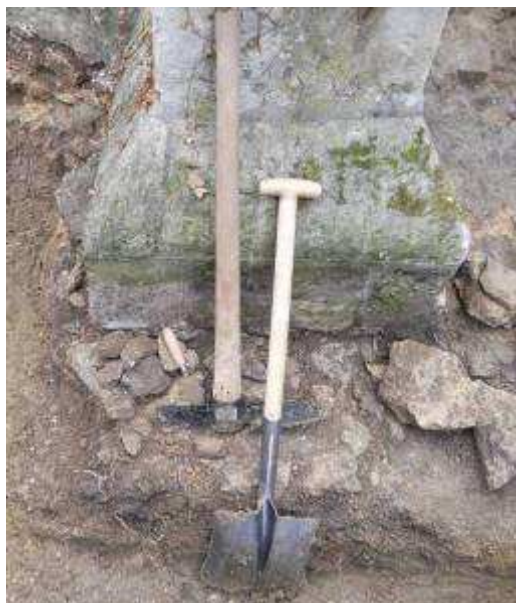
Figure 35 Rounding the NE buttress minimal signs of [1044] in Sector C but lower structure [1037], having right-angled southwards under buttress and [1044], reappears running N-S as [1038] (see left top of photo). At the NE end of the NE buttress it is difficult to discern if, in this area, the base on which the buttress is sitting are part of [1044]. Noting the less substantial stone used here it is more probable that these stones formed part of later buttress bolstering (similar to rubble to W of N buttress).

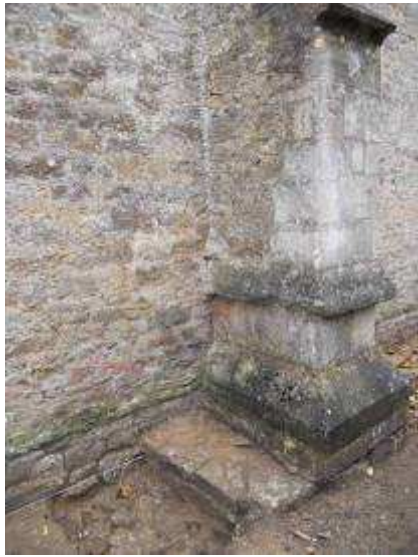
***Figure 36** The flagstone courses of [1045] can be seen E of the N buttress base. [1045] runs under the buttress to W and the chapel wall to S; the W end of the lower structure [1037] (minus its top stonework course at this point) runs W under [1045] and continues westwards in Sector A as [1036] (just visible to). The lower level of the existing chapel N buttress appears to have been 'dressed'/ repaired with chamfered stone – clearly different to the upper courses where the stone used ties in with the chapel stonework (similar to the NE buttress).*

Structure [1045], oriented c. N-S, under (1000), is centred on (18.25, 19.5); its dimensions are 1m N-S x 0.49m E-W x 0.36m in height. It is clearly seen to be lying **over** structure [1037] and its substantial stone slabs extend **under** both the north chapel wall to S and the existing N buttress to W. (See related context [1044]). Well preserved, it comprises c.3 fairly regular courses of substantial, dressed, fair-faced limestone irregular slabs bonded with orange sandy fine mortar on the top layers, with greyer mortar used in the lower courses.

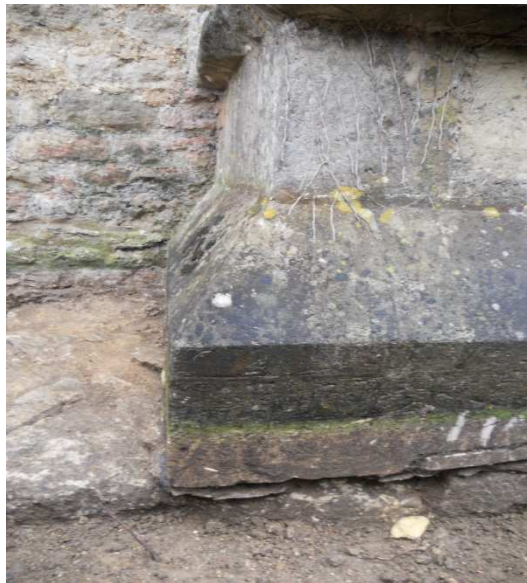
***Figure 37** Large flagstone of [1045] runs W under two-thirds the width of N buttress. The buttress overhangs [1045] to N by 0.07m. It has been packed out to W of buttress to form a base for the later built buttress.*

On trowelling back the S edge of the abutting chapel path, it becomes clear that the most substantial visible top-course flagstone/slab of [1045], situated at its NW corner (its N edge measuring 0.79m), runs under three-quarters of the width of the N buttress which has been built upon it. However the N edge of the [1045] flagstone is not in exact alignment with the N end of the existing buttress; the flag is set back to S by c. 0.07m, so the later existing buttress slightly overhangs [1045] to N. Also the top course of [1045] has been added to/ packed out in the west with rough-hewn un-worked stone, under the W side of the existing later N buttress, to form foundations for this later buttress. In Sector A layer (1021) there is evidence of further strengthening of these packed-out foundations to W of the N buttress.
